Home Inspection Report

PROPERTY INSPECTED:
W13467 Wisconsin 64
Lublin, WI 54447

Date of Inspection: 05/15/2023

Inspection No. 421253-1-702

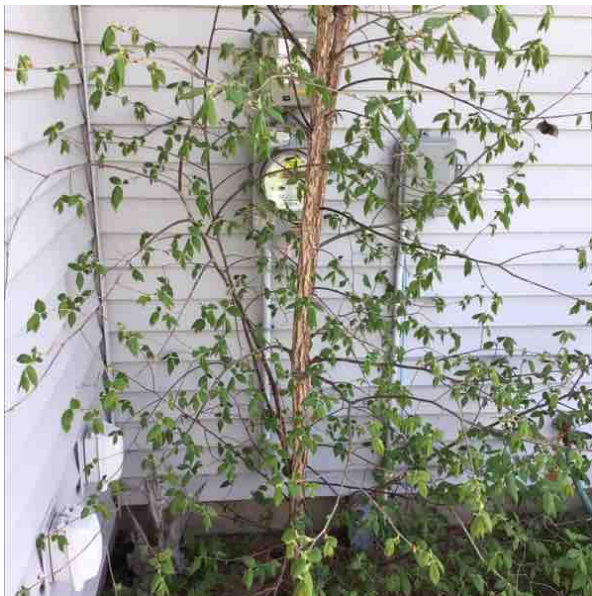
2.1.1 Trim and maintain trees, bushes and vines away from the structure to minimize damage/wear to structure and to discourage animal activity. **(Exterior Right)**

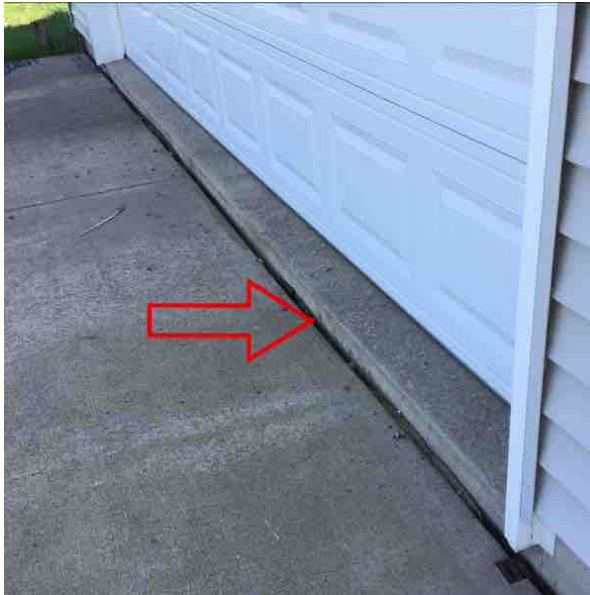
2.3.1 The driveway has a more than typical sunken area between the garage and driveway apron that create a potential trip hazard. Have a qualified cement contractor further evaluate and repair or replace for functionality and added safety. **(Exterior Right)**

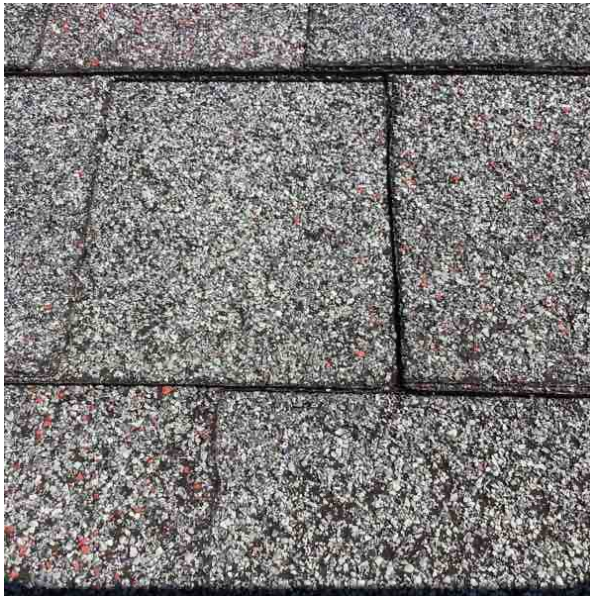
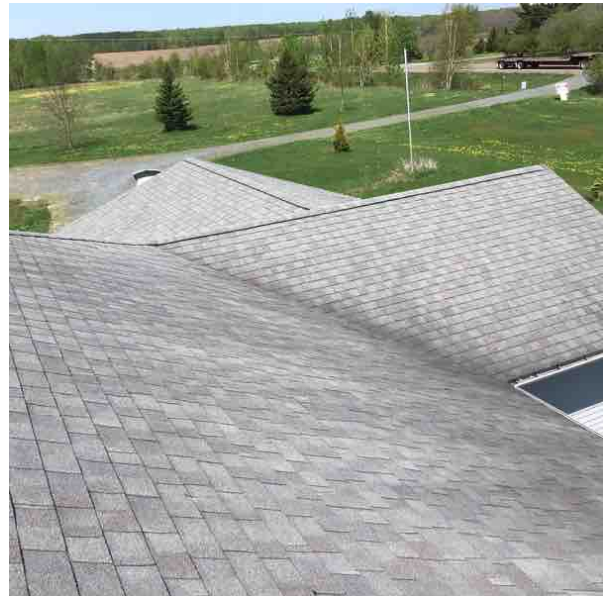
4.3.1 There are signs of wear which are consistent with the normal aging process of this roofing material. While the roof covering is not new, it appears to be performing adequately and as intended. No improvements necessary at this time.

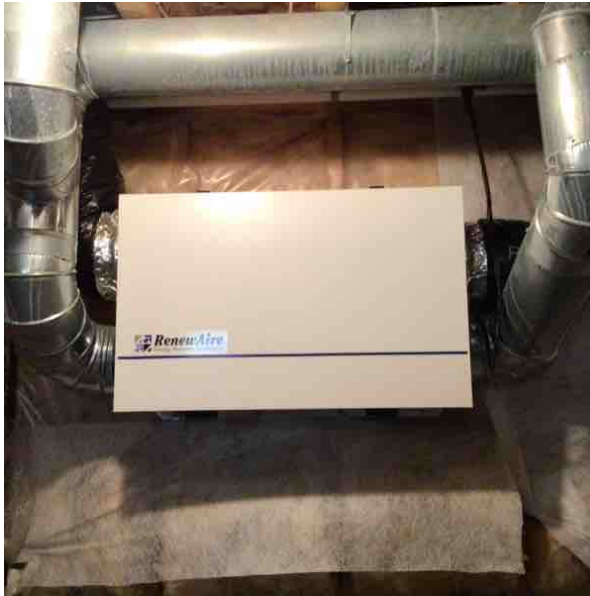
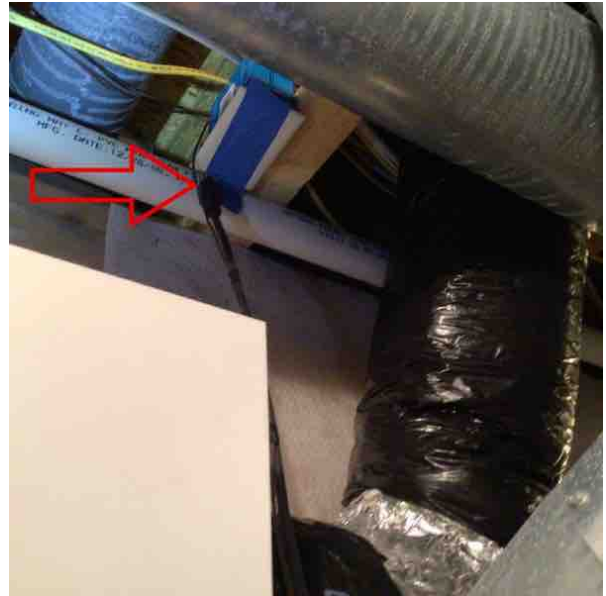
9.8.1 The heat / energy recovery ventilator is inoperative (not plugged in). A qualified HVAC contractor should repair as required to restore proper function. **(Basement)**

9.8.1 The heat / energy recovery ventilator is inoperative (not plugged in). A qualified HVAC contractor should repair as required to restore proper function. (Basement)

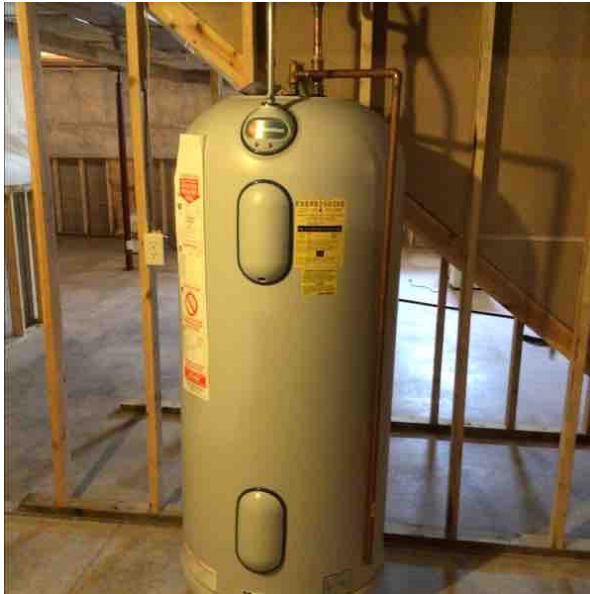
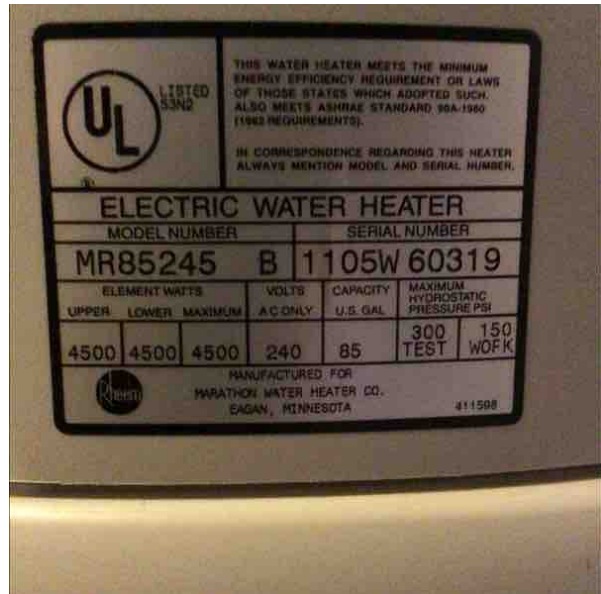
10.6.1 Dad of manufacture 2005 (**Basement**)

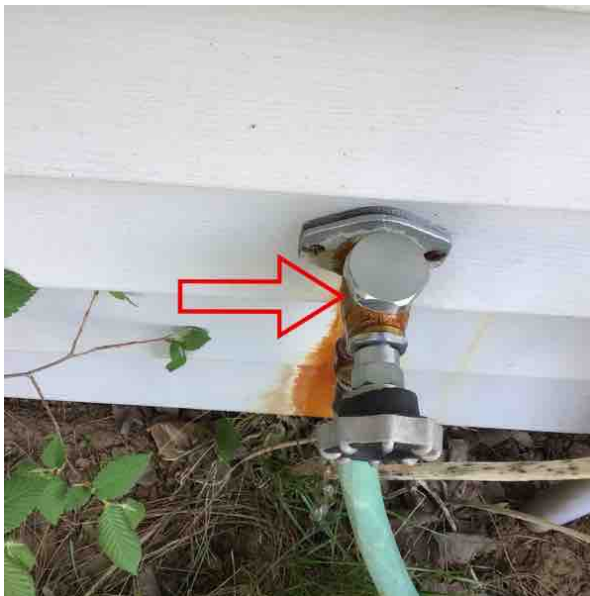
10.7.2 The hose bibb is leaking. A qualified plumber should further assess and repair as required to restore proper function. (**Exterior Right**)

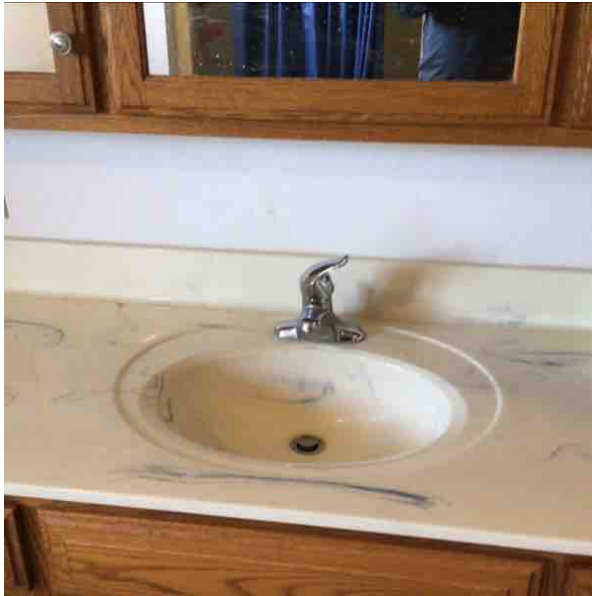
10.8.1 The master bathroom faucet was operated but was not functional (no cold water). A qualified plumber should further assess and repair as required to regain proper function. **(Master Bathroom)**

10.8.1 The master bathroom faucet was operated but was not functional (no cold water). A qualified plumber should further assess and repair as required to regain proper function. (Master Bathroom)

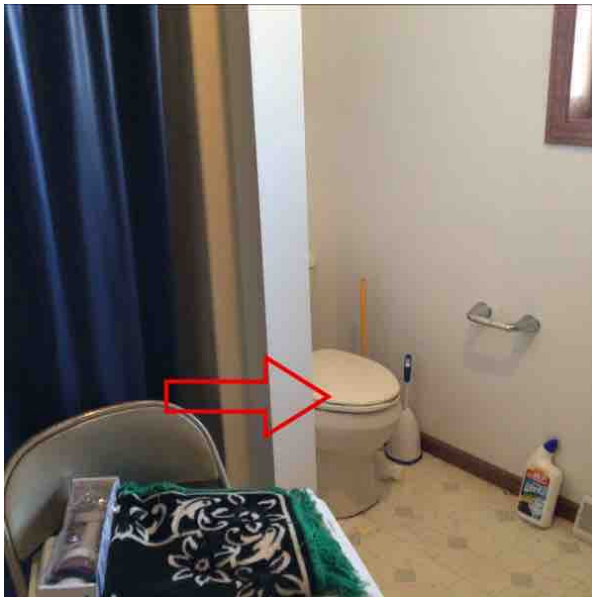
10.10.1 The master bathroom toilet is inoperative. A qualified plumber should repair as required to restore proper function. **(Master Bathroom)**

10.10.1 The master bathroom toilet is inoperative. A qualified plumber should repair as required to restore proper function. (Master Bathroom)

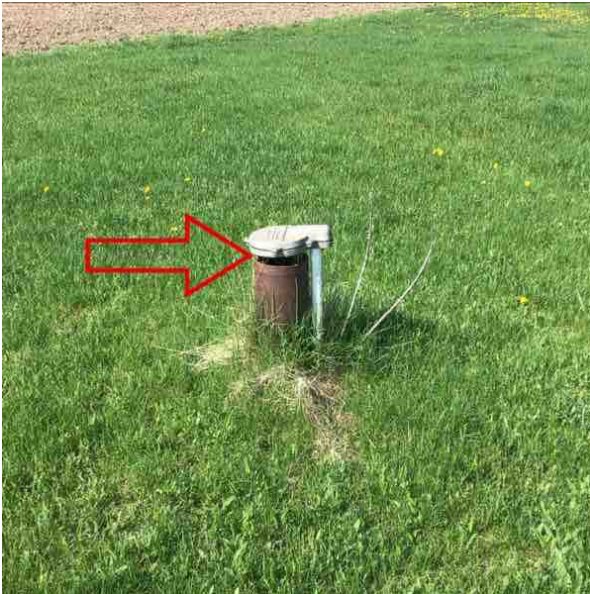
10.13.1 This property is served by a well system. A certified inspection was not ordered. Recommend having a qualified well professional further evaluate and ensure the system is operating as intended (**Exterior Back**)

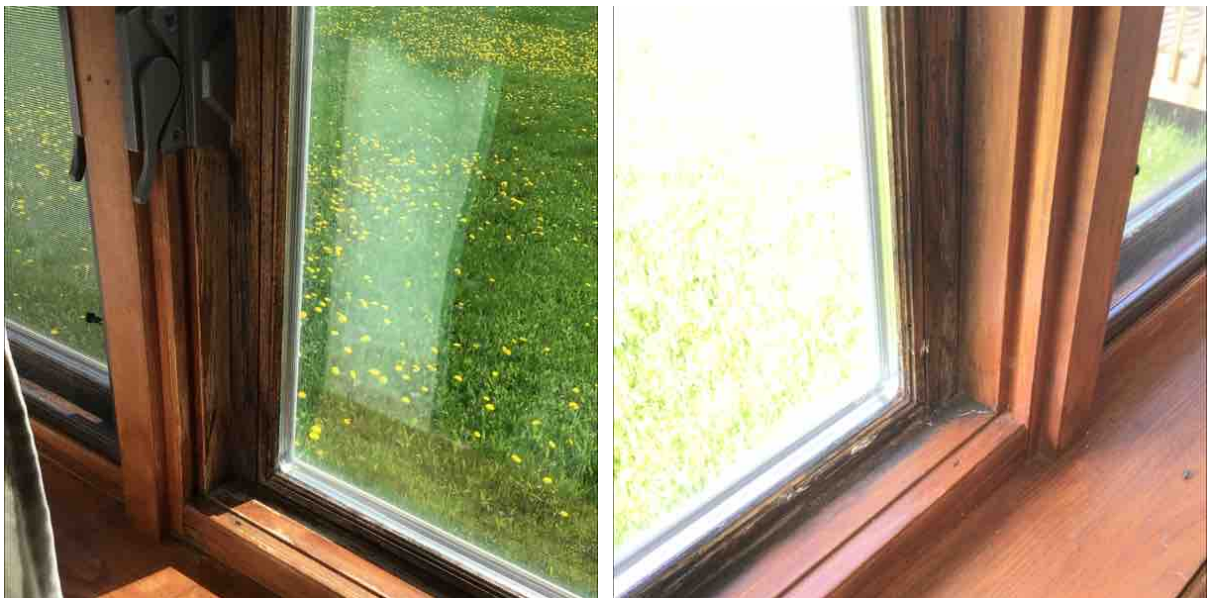
11.5.2 Condensation damage on all of the wood frame windows present. Have a qualified window contractor further evaluate and repair or replace as needed.

11.5.2 **Condensation damage on all of the wood frame windows present. Have a qualified window contractor further evaluate and repair or replace as needed.**

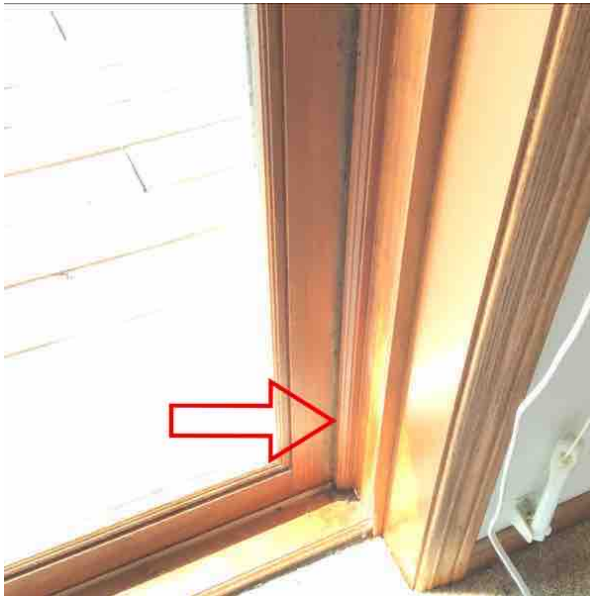
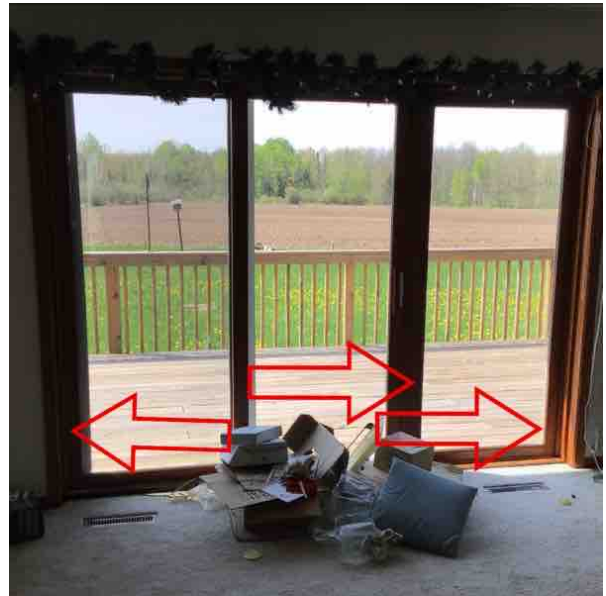
11.7.1 Sliding glass door has moisture related damage. Have a qualified door contractor further evaluate and repair or replace as needed. **(Living Room)**

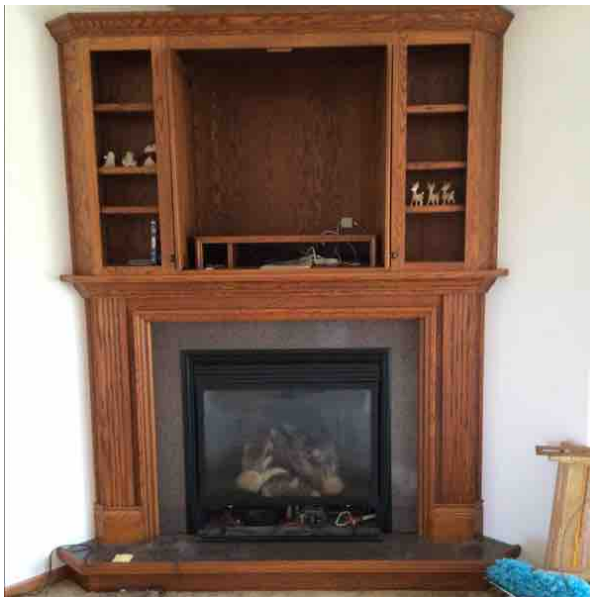
12.1.1 The fireplace did not respond to normal operating controls. Gas appears to be shut off/pilot light not lit. Prior to closing, verify with sellers the functionality of the unit and the procedures for lighting fireplace. **(Living Room)**
