Inspection Report

12151 97th St

Milaca, MN 56353

October 6, 2021

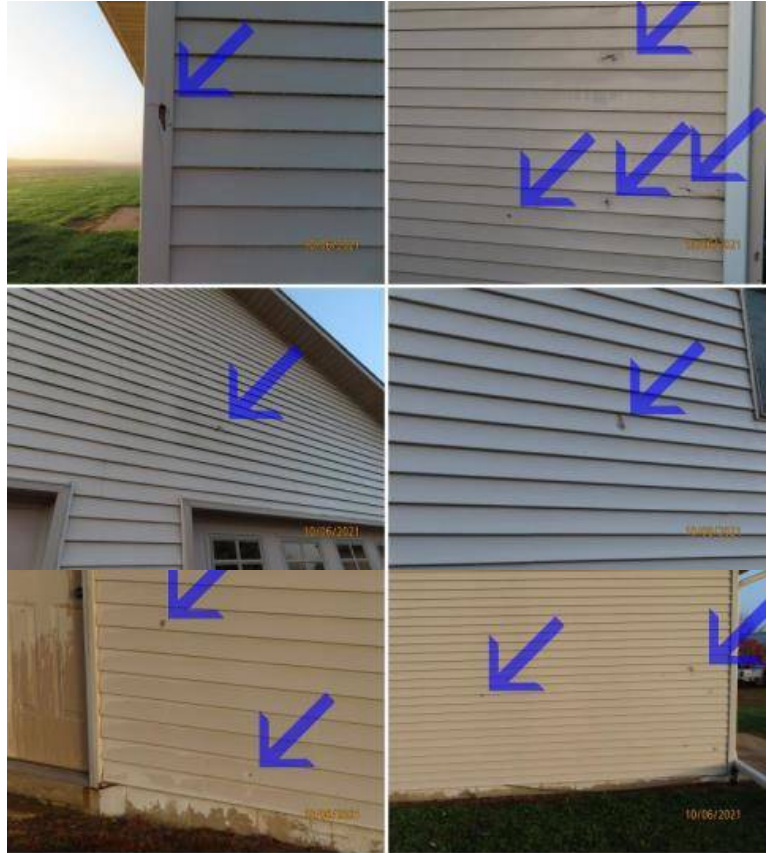
Appears serviceable,
Cracks noted are
typical.

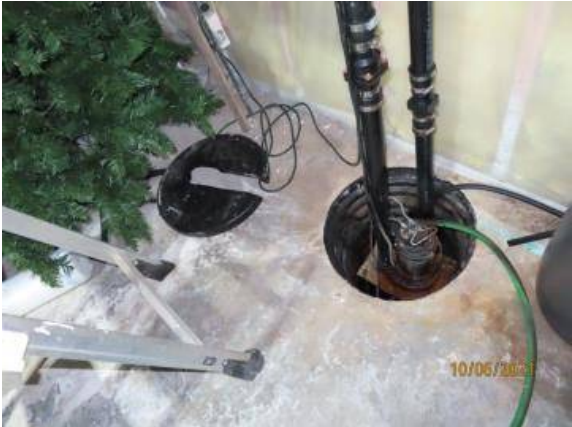
Floor drain, Appears serviceable,
Sump pump appears serviceable.

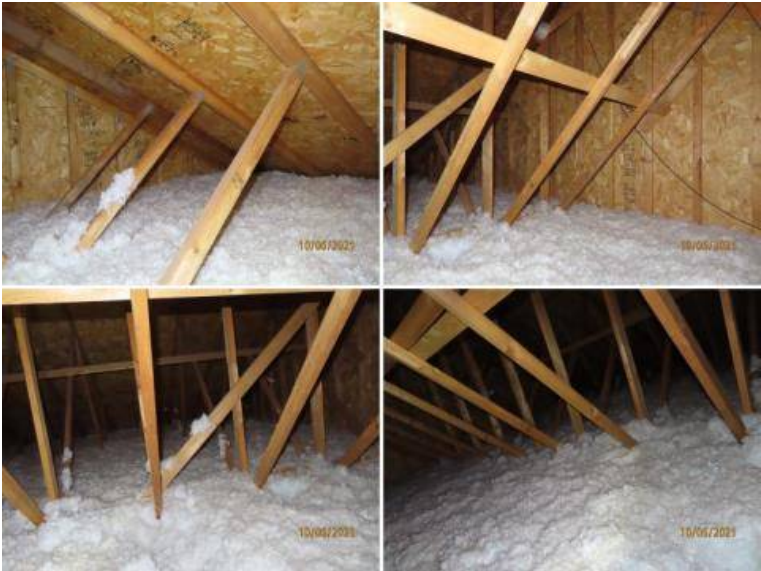
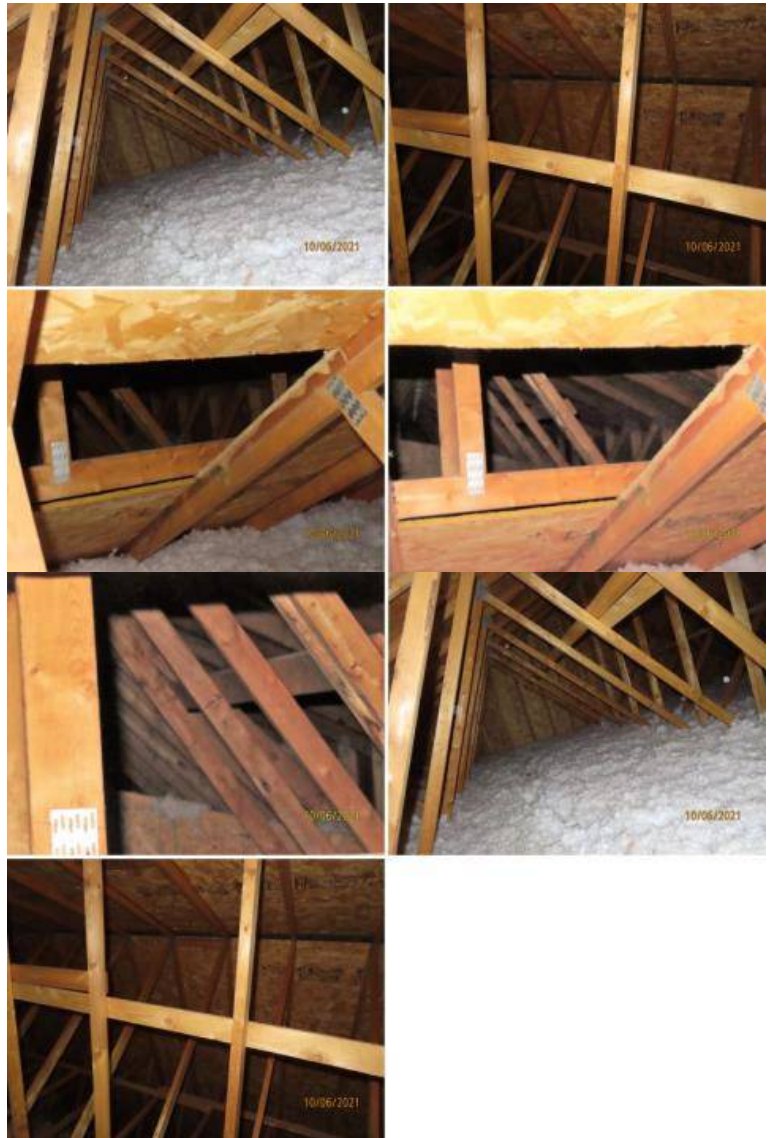
Attic is partial, Truss
framing, Appears
Serviceable, Viewing
was limited, to
observing from hatch
areas only. Ventilation
is provided.

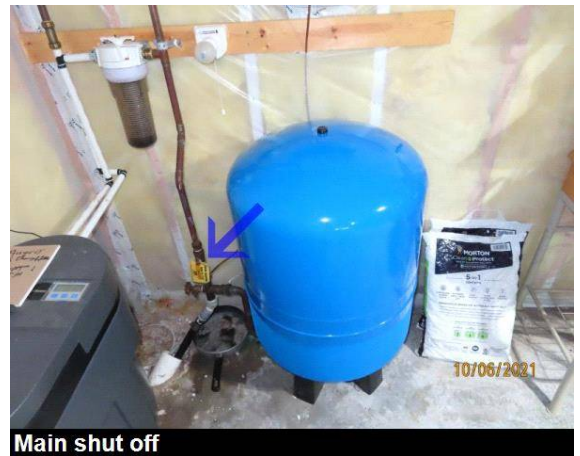
Main shut off

CONDITION: Appears serviceable, Valve is operational, Water softener installed - NOT PART OF THIS INSPECTION, Main line is 1" inch diameter, Water pressure appears adequate.

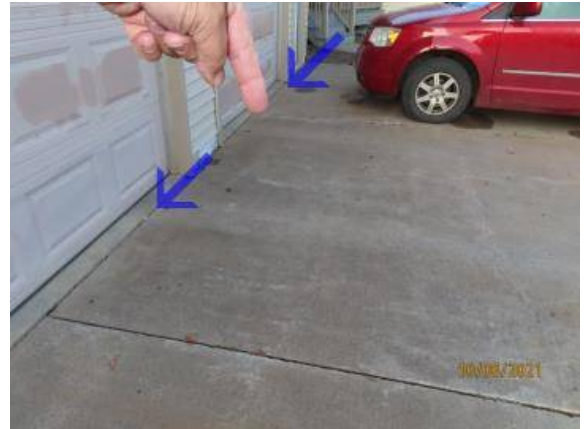
CONDITION: Appears serviceable, Cracks noted are typical. [Surface raised/settled](#), Gravel.

Appears serviceable, Cracks noted are typical. [Surface raised/settled](#), Gravel.

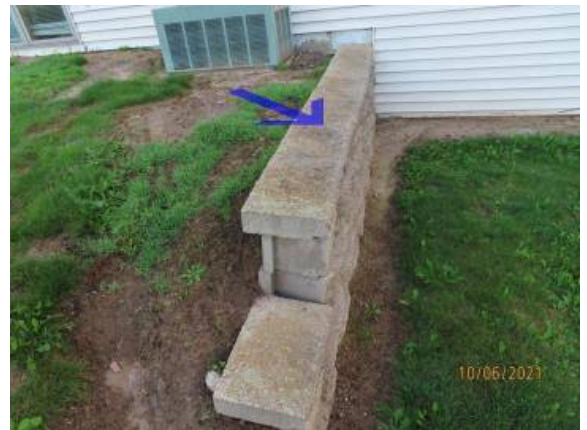
TYPE: Masonry.
CONDITION: Appears serviceable, [Displacement/Cracks typical](#).

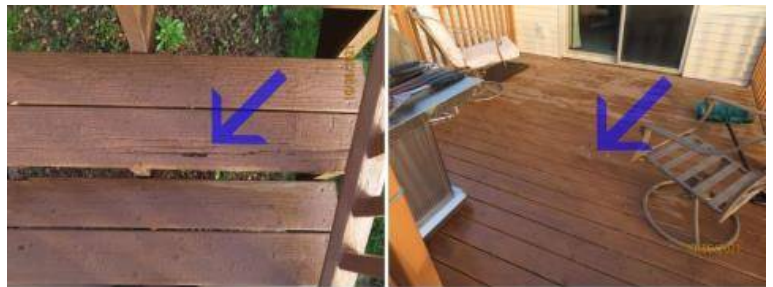
Appears serviceable, Deterioration noted to deck surface.

Appears serviceable, [Deterioration noted to deck surface.](#)

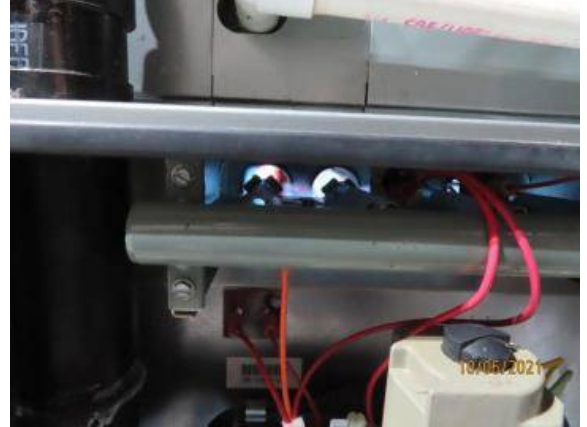
Burner Flame(s) appear typical, **Unusual flame pattern noted, Humidity could be a factor, tune up suggested,** The heat exchanger portion of a gas or oil fired heater is difficult to access without disassembly, and cannot be adequately checked during a visual inspection.

Burner Flame(s) appear typical, [Unusual flame pattern noted](#), [Humidity could be a factor, tune up suggested](#), The heat exchanger portion of a gas or oil fired heater is difficult to access without disassembly, and cannot be adequately checked during a visual inspection.

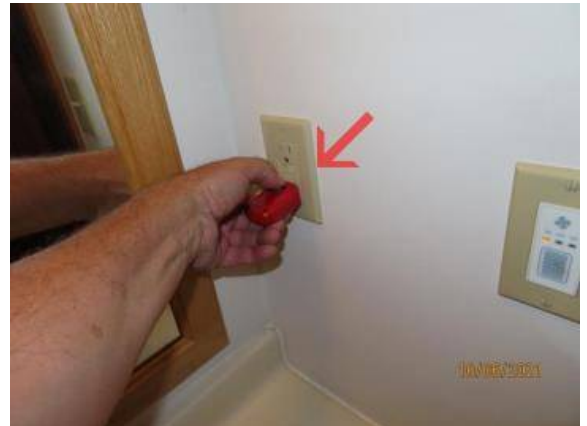
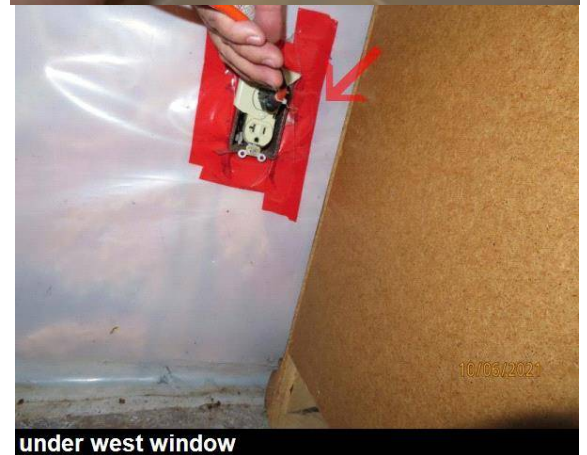
A representative sampling of switches and outlets was tested. As a whole, outlets and switches throughout the house are in serviceable condition. Stored items prevent access and testing at some outlets and switches.
 GFCI not operational, 1/2 bath.
 Missing or damaged cover plates viewed, Basement utility room.

A representative sampling of switches and outlets was tested. As a whole, outlets and switches throughout the house are in serviceable condition. Stored items prevent access and testing at some outlets and switches. [GFCI not operational, 1/2 bath. Missing or damaged cover plates viewed, Basement utility room.](#)

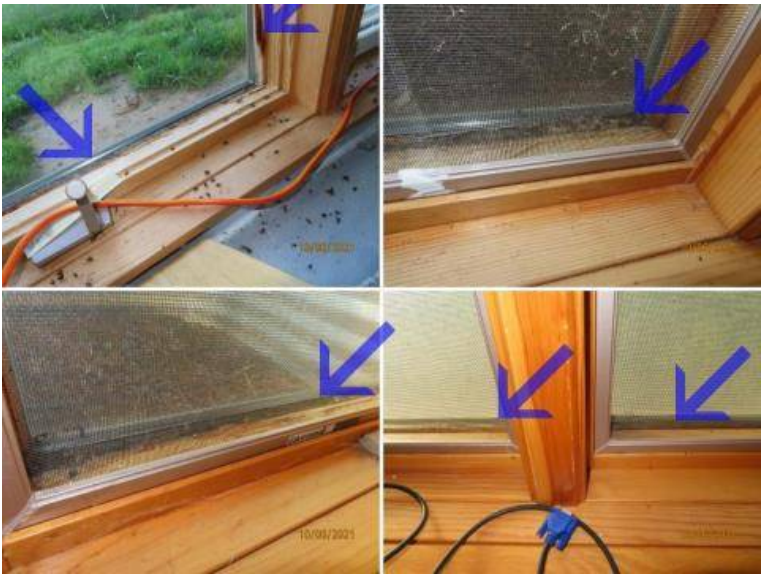
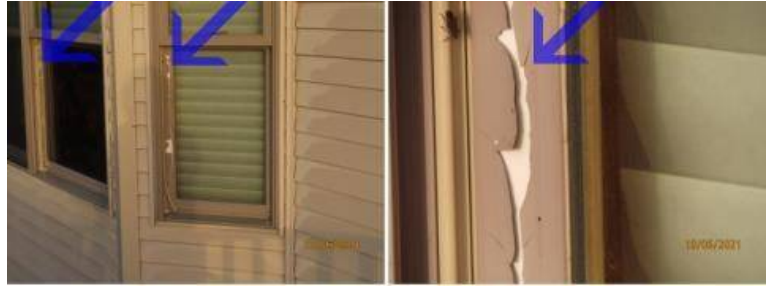
Wood,
Clad-Metal/Vinyl,
Insulated glass,
Double hung, Finish
repair needed, finish
Damaged from
moisture/sun. A
representative
sampling was taken.
Windows as a
grouping are
generally operational.

Wood, Clad-Metal/Vinyl, Insulated glass, Double hung, **Finish repair needed, finish Damaged from moisture/sun.** A representative sampling was taken. Windows as a grouping are generally operational.

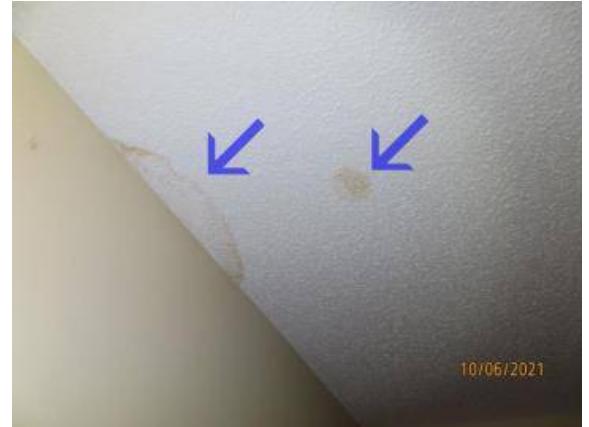
TYPE & CONDITION: Drywall, General condition appears serviceable. Stains noted, Unable to determine if active leakage exists. Make inquiry with the seller as to the history of leaks, Tests dry today, below kitchen sink/dishwasher, no leaks detected there.

Drywall, General condition appears serviceable. **Stains noted, Unable to determine if active leakage exists.** Make inquiry with the seller as to the history of leaks, **Tests dry today, below kitchen sink/dishwasher, no leaks detected there.**

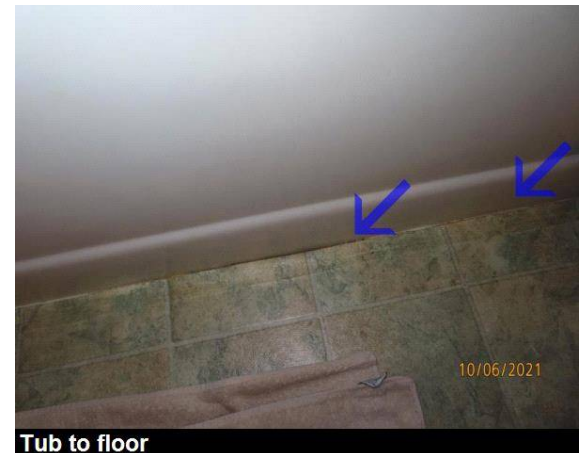
Tub to floor

TUB/SHOWER AND
WALLS: Tub and shower areas appear serviceable, [Caulk and seal all tub and shower areas as a precaution.](#)
